TRINITYRAIL®

SealSafe® Radial Door Inspection and Repair Manual

Draft F – September 24, 2015

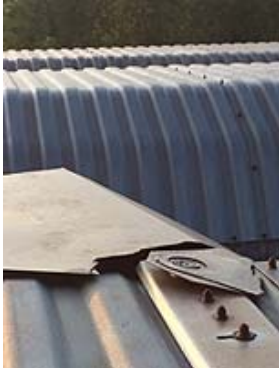
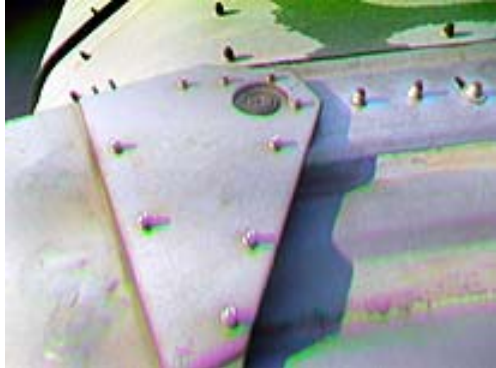
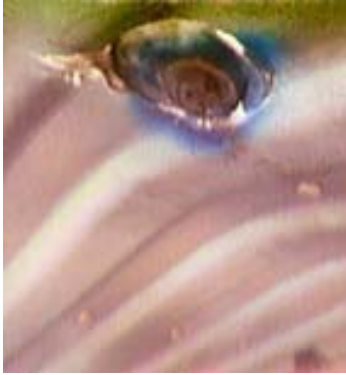
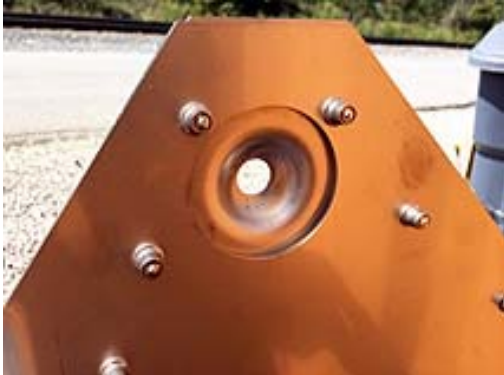
Replace in kind or with an NRC Huck Pivot Upgrade as directed by the rack owner

Original Hood without Doubler Plate Application	Original Hood with Doubler Plate Applied

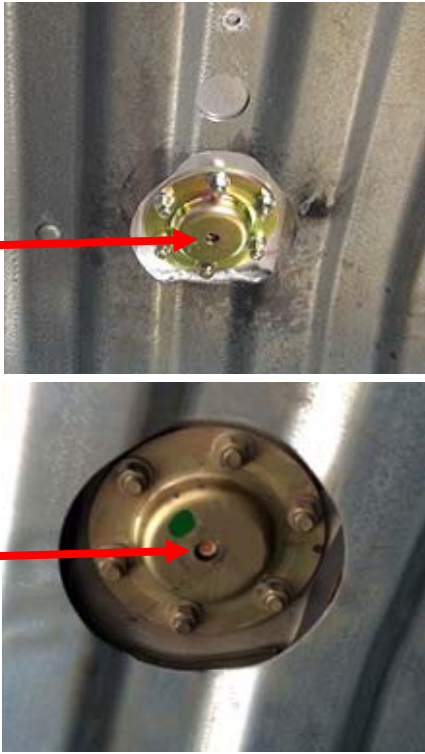
NRC Generation I

Replace with NRC Huck Pivot when needed.

<p>Small Inspection Access Hole</p>

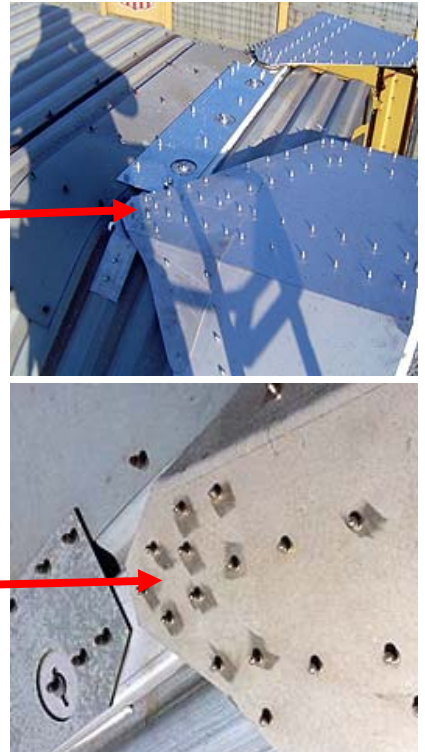
<p>Top Flush Hood</p>

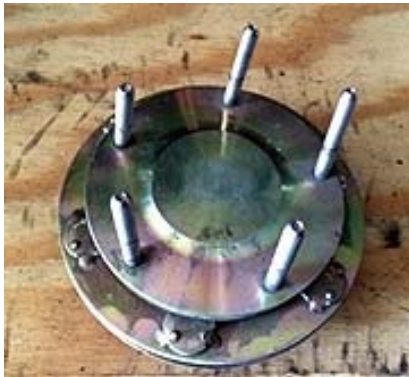
<p>Generation I Top Bearing Pt. Flush</p>

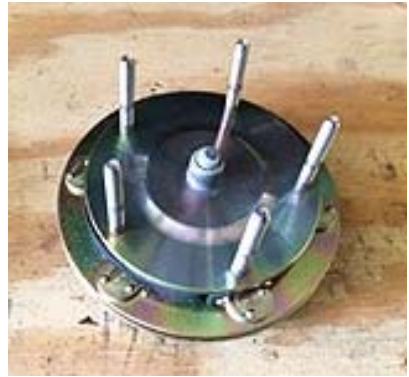
Generation II Huck Bolt	
<p>Generation II Huck Bolt Top</p>

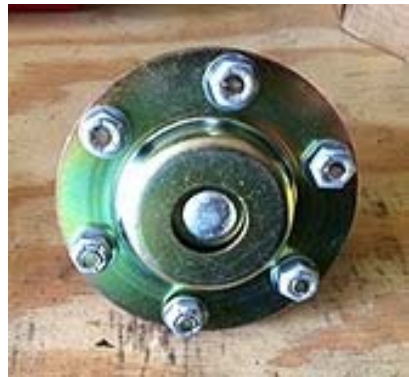
<p>Generation II Huck Bolt Bottom</p>

Comparison of Generation I and Generation II	
<p>Top View</p>	  <p>Gen I Gen II</p>
<p>Bottom View</p>	  <p>Gen I Gen II</p>

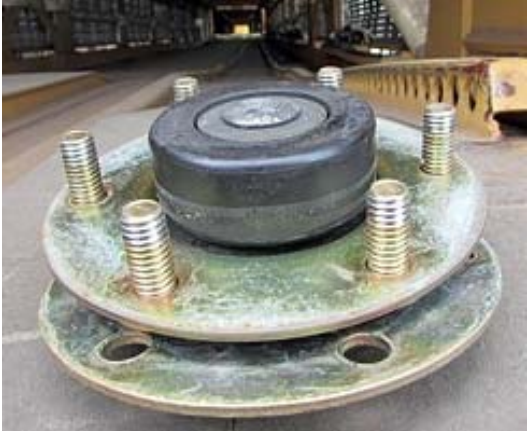
<p>Replace complete pivot as an assembly.</p> <p>NRC Huck Pivot assembly on deck before installation.</p>

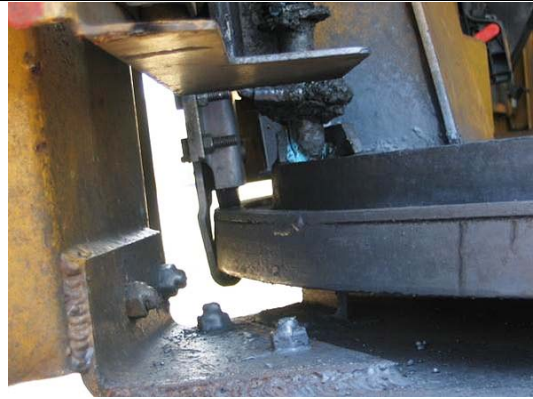
Radial End Door Track Arrangement

Radial end door track arrangement for bi-level and tri-level autoracks equipped with SSRD.
